**DANUBE PARKS (SEE/A/064/2.3/X) - Danube River Network of Protected Areas -
Development and Implementation of Transnational Strategies for the
Conservation of the Natural Heritage at the Danube River (South East Europe)**

Revitalisation of the Danube distributary in the Devín area

A S T U D Y

May, 2011, Bratislava

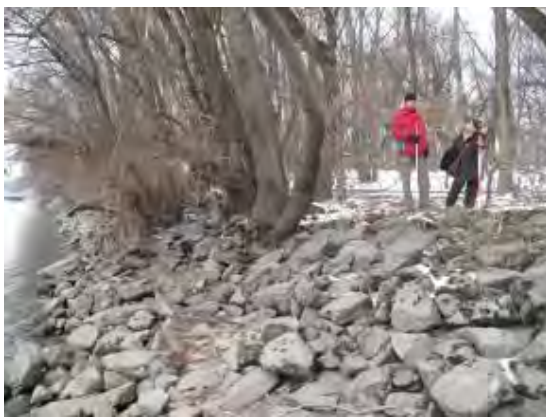
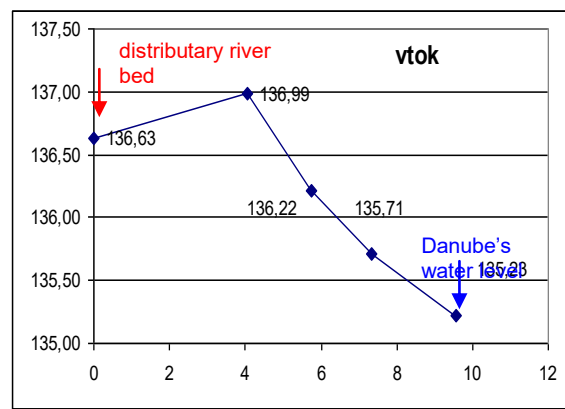
The inlet (Fig.12) into the distributary is located in the km 1879.40 (the Danube) in the altitude of app. 137 m.a.s.l. and the outlet in the km 1878.15 in the altitude of app. 136.0 m.a.s.l. At the present time it comes to flowing of the Danube's waters into the upper part of the distributary only when the discharge is higher than $3\,300\text{ m}^3\text{s}^{-1}$. In the lower part the interaction of waters occurs when the discharge is higher than $2\,800\text{ m}^3\text{s}^{-1}$. In the periods of mean discharge, backwater remains in the lower and middle part of the distributary, whilst the upper part remains often without water. During low discharges and drought periods the water level in the distributary decreases and also the water area reduces. Merging of the Danube's

a) Fig.12 inlet into distributary, (a) levee by the inlet, (b) levee height in the inlet into distributary

1 – Upper section – from the inlet to the road communication: The inlet is separated from the Danube by a high levee of fractured stone (Fig.12a, Fig.13a). Behind it, there is a narrowed part of the distributary of the width $B \sim 10$ m, which gradually widens up to ~ 30 m in the length of 80 m.

- Opening of the distributary in the inflow area – removal of bunding and improvement of the height of the inlet top to the altitude 135.00 m.a.s.l., building of an intake structure
- Improvement of the profile in the area of the road communication connected with the reconstruction of the roadway – increasing of the flow capacity of the profile

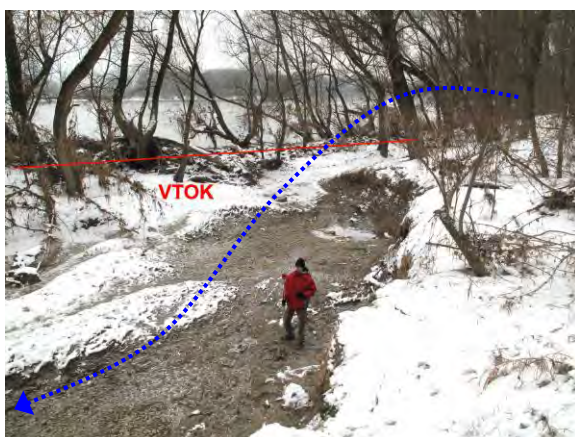
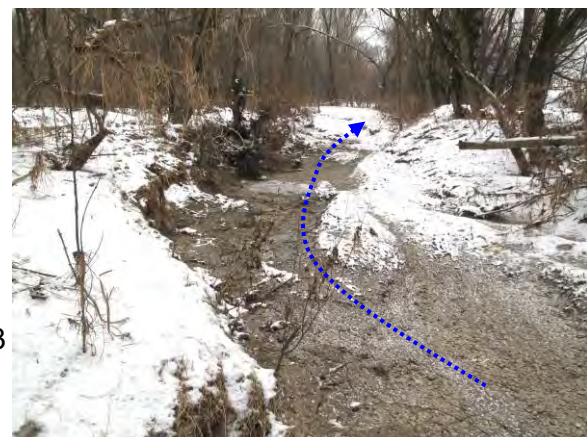
The distributary river bed level is greatly unequal in this section (Fig.11a). Obviously, this part will require terrain improvements the extent of which will depend on the height of the inlet top. The distributary length after dyking is 290 m, whereby more than its half is frequently without water (13d). This section remains mostly dry and without water during the year.

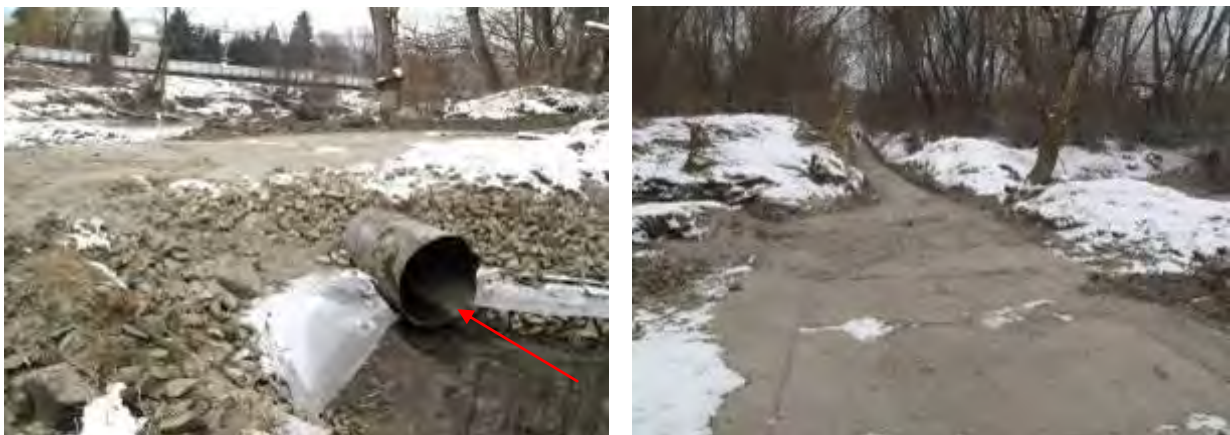
2 – Middle section - from the road communication to the island: The distributary is dammed through a road communication which is basically the only access route to the island creating the distributary. The road communication consists of stone levee which is reinforced by concrete blocks on the surface (Fig.14).

a) b)
Fig.14 Interconnection of the distributary through a pipe culvert – upper part (a) roadway (b)

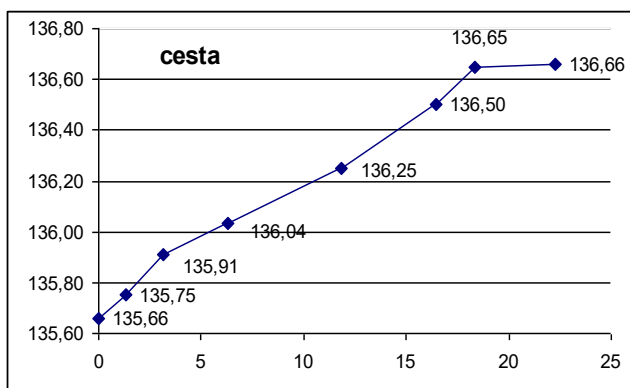
The height of the road top varies and in the distributary area it gradually rises in the left to right direction from 135.66 m.a.s.l. to 136.66 m.a.s.l. (Fig.15). The length of dyking across the distributary is ~ 35 m and the road is ~ 3 m wide.

Fig.15 Height measurement of the road across the distributary

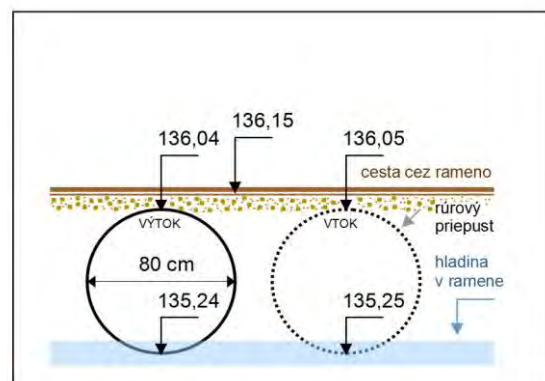
Fig.16 Pipe culvert scheme

The interconnection of the distributary is provided by a single 80 cm diameter pipe culvert (Fig.16) which is in terms of flow capacity totally insufficient considering the 35 m width of the distributary. If the Danube's water level in the inflow area goes over the height ~ 137.00 m.a.s.l., the water flows into the upper part, but the distributary only fills with water, as there is only minimum discharge through the pipe culvert. The road communication creates a practically impermeable barrier on the distributary; full flow capacity doesn't occur until the water level goes over the top of the road (over ~ 136.0 m.a.s.l.). Accordingly, this profile is critical in terms of functional flow restoration in the distributary; therefore it is necessary to propose suitable measures in this section with the aim to increase its flow capacity.

The most optimal way for a complete restoration of natural flow dynamics in the distributary would be the complete removal of the road communication and thus the restoration of the original distributary capacity in this profile. As the road through the distributary is the only connecting communication for the entire island, it is necessary to propose a solution which considerably increases the flow capacity of the profile and, at the same time, makes the preservation of the road possible.

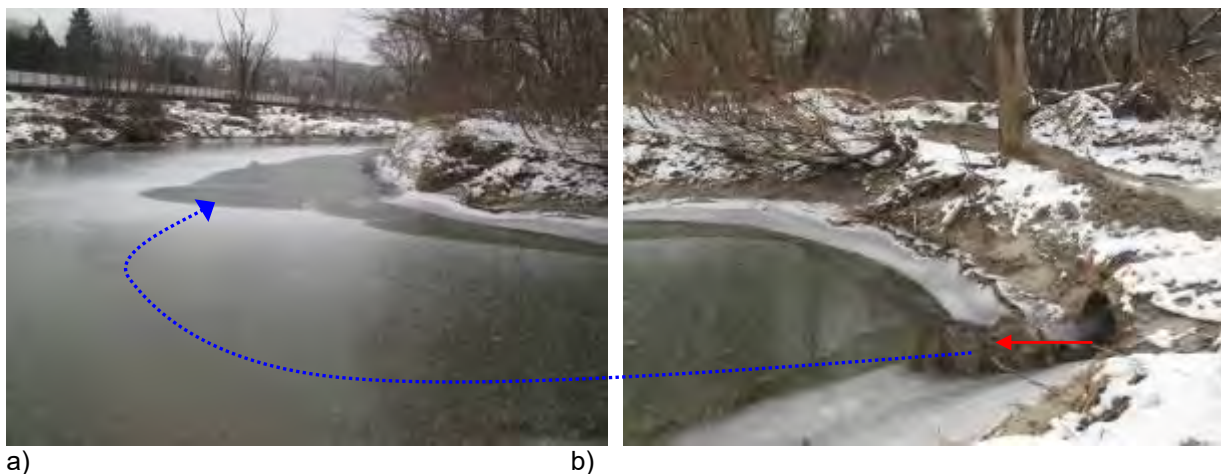
a) b)
Fig.17 Interconnection of the distributary through a pipe culvert (b), the distributary in the area below the road (a)

Below the dyking the distributary gradually widens (Fig.17) to the width from B ~ 40 to 50 m with the maximum width of 65 metres in the profile 9 in the km 0.75. The river bed gradient in the area from dyking to estuary is more favourable for the flow capacity – the deepest river bed gradually sinks from 134.80 m.a.s.l. to 134.00 m.a.s.l. However, in the longitudinal profile

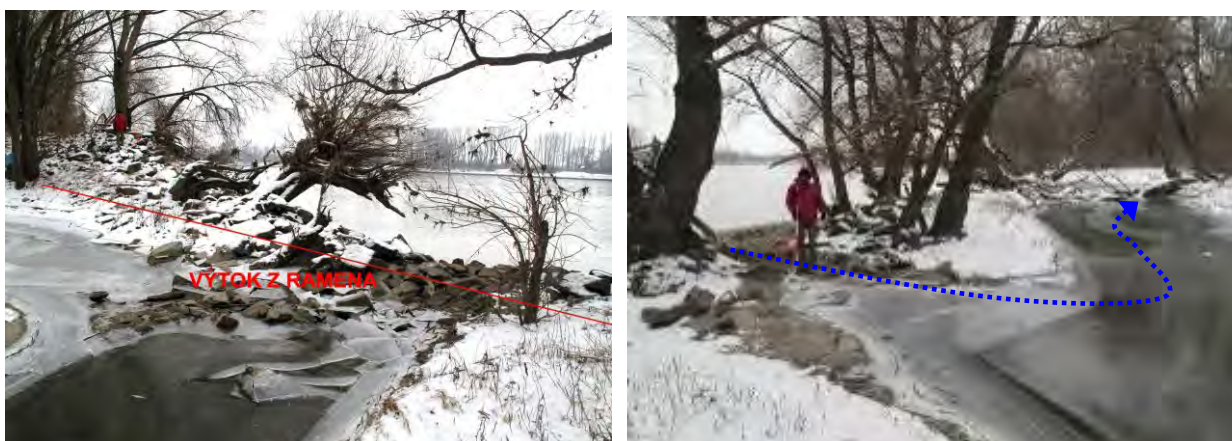
a) bunding in the outflow area

b) bank line – between the Danube and the distributary

Fig.18 The outflow area out of the Devín area distributary

Along the lower branch of the distributary adjoining with the Danube the bunding is relatively low. The water from the Danube flows into the lower part of the distributary through several

terrain cavities (Fig.18b, Fig.19b). The energy from the Danube's flow had decomposed the bunding in several parts and created its natural ways of interconnecting with the distributary. These "naturally created" interconnections can be left without improvement as complementary to the distributary opening in the outflow area (if the water level goes over app. 135.5 m.a.s.l. ~ i.e. for discharges higher than $2400 \text{ m}^3\text{s}^{-1}$) to the main interconnection to the inlet.

- Opening of the distributary in the outflow area - of bunding and improvement of the height of the inlet top to the altitude 134.00 m.a.s.l., eventually 134.5; outlet improvement
- River bed improvement (degradation of the river bed) in the inflow and outflow section in the selected locations where the river bed presents an obstruction for flow restoration; removal of deposits of alluvial wood and tree branches in the lower part of the distributary (near the outflow area - in the bifurcated branches of the distributary around the small island).

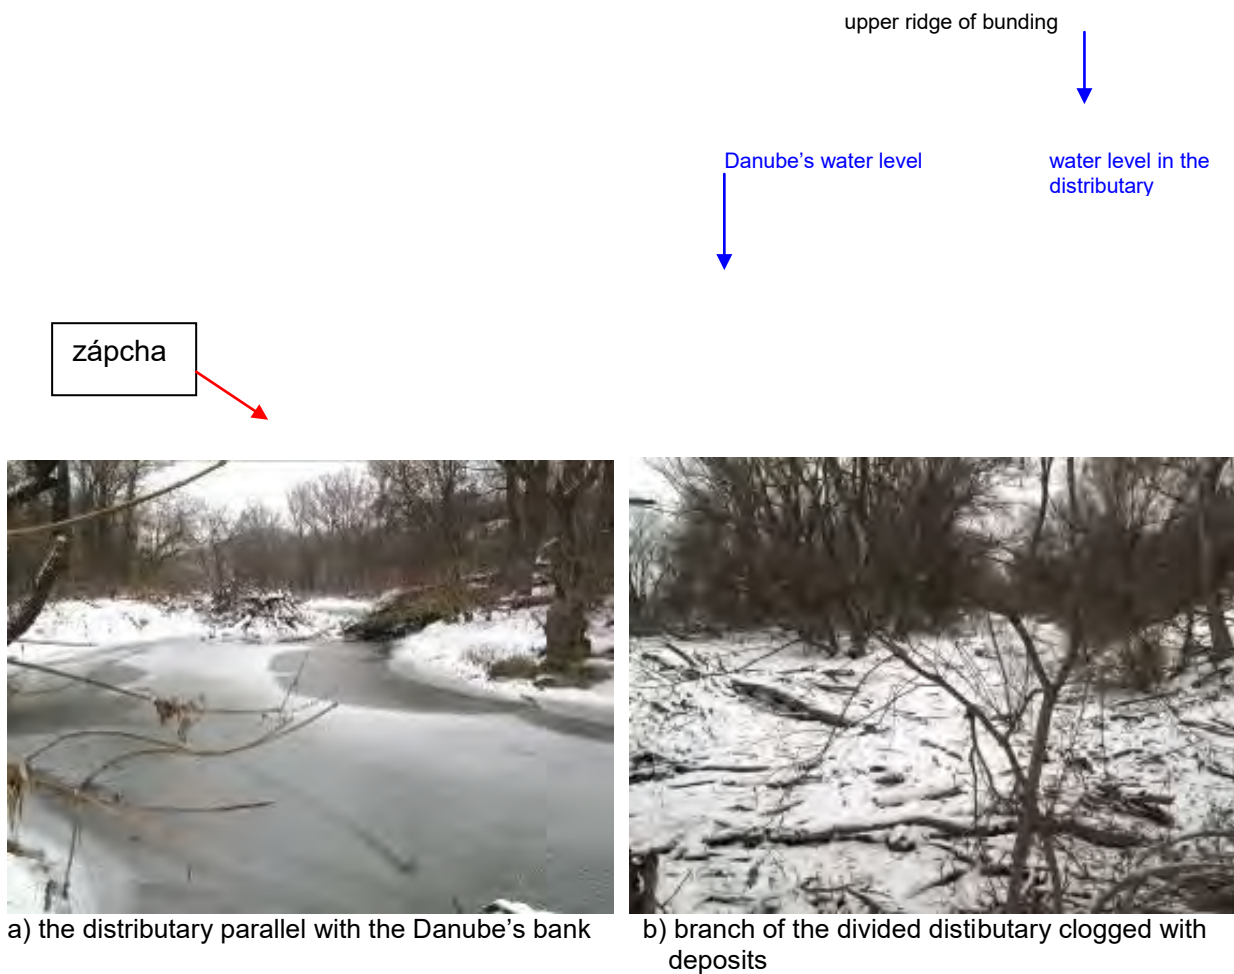
3 – Lower section – from the island to the outlet: The island in the outflow area divides the distributary into two branches. Both branches are clogged with deposits of tree branches, trunks and sediments (Fig. 11 and Fig.20b). These deposits need to be removed and the river bed height needs to be adjusted. Degradation of the river bed to 134.00 in the outflow area will secure the watering of the distributary from the lower side by the level of HNR PV (LDC) + 40 cm, which equals the discharge of $\sim 1\,250\text{ m}^3\text{s}^{-1}$. The average height of the bunding in the outflow area is 136.00 m.a.s.l. (Fig. 19a). The estimated outlet width is 25 metres.

Fig.20 Distributary in the outflow area – divided into two branches by a small island
